Advisory Visit Water of Milk – Dumfries and Galloway Scotland

20/10/2018

This report is the output of a site visit to the Water of Milk, a tributary of the River Annan, at the request of the River Annan Trust. The purpose of the visit was to assess options for habitat improvements and riverbank stabilisation in an embanked section of watercourse.

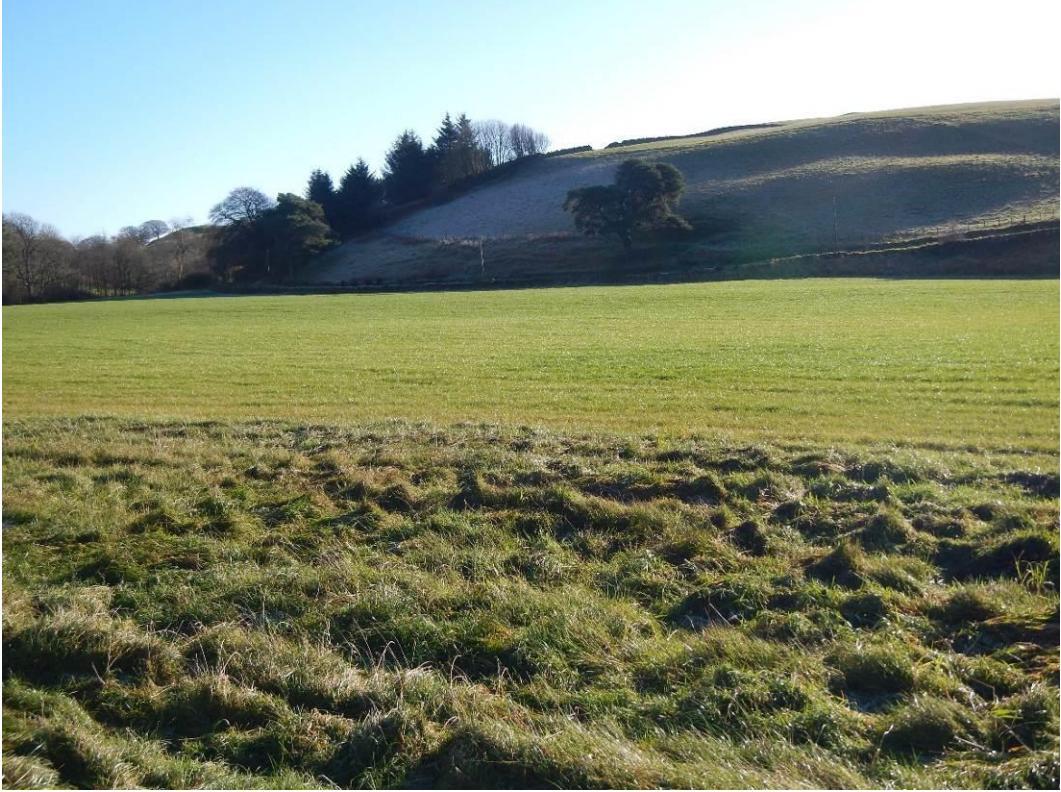
**Figure 1.** Looking from the river bank out across lower-lying areas of the floodplain in the foreground and up to the LB valley side (background).

The site visited lies immediately downstream of a much steeper-sided valley section, within a natural floodplain area traversed by numerous low points and former river channels (Fig. 1). Historically, medium and high flows would have regularly spilled out of the channel onto the adjacent land, flows energy and depositing fine sediment (silt) and nutrients. Consequently, the adjacent land is some of the most productive in the area.

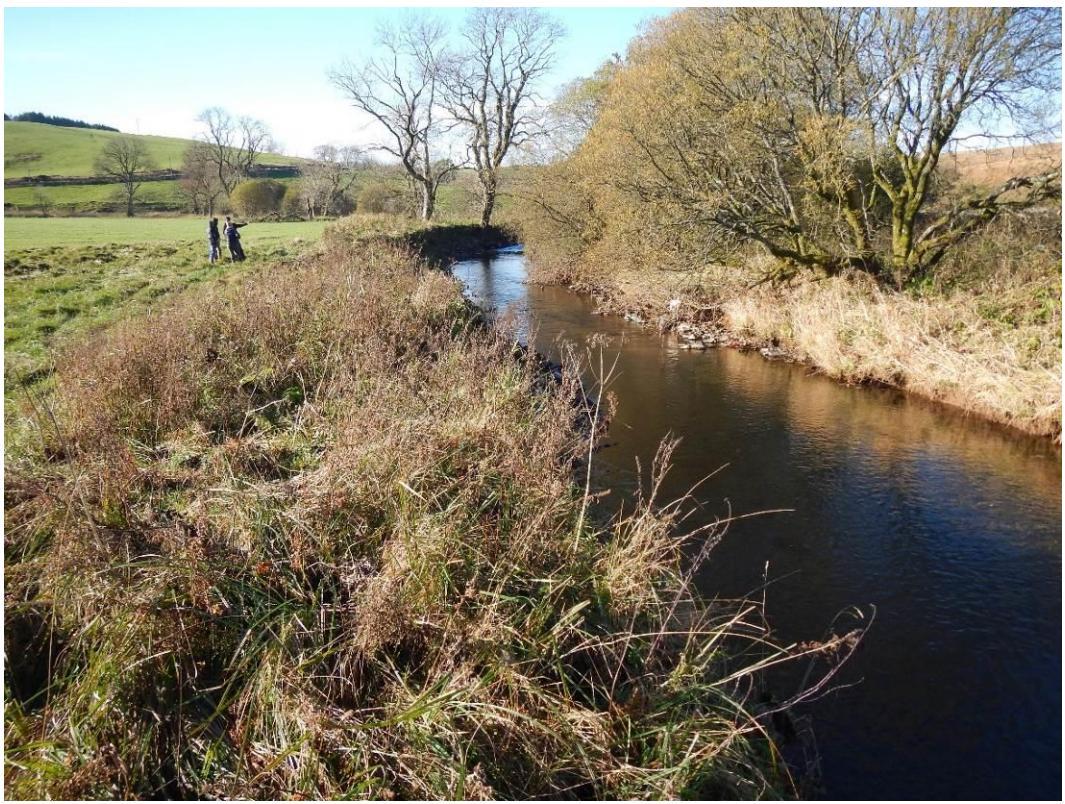
**Figure 2.** Looking downstream at the erosion site (LB). Note the reasonably well vegetated bank top (left of shot) - sheep generally favour the grass regrowth in the mown areas to the left of shot. However, also notice the lack of trees, shrubs and tree regeneration, with only a few mature trees present. This area of the left bank comprises incohesive, coarse material and is overly steep, with a raised flood embankment on top, all of which is greatly contributing to the erosion issues. Also note the more stable, treed areas on the RB.

In conjunction with improvements to the banks, excluding livestock from the riverbank would be a necessity (and highly beneficial even without the bank improvement work), to allow the bank to revegetate and for trees to establish that will improve bank stability in the long term. The fencing should be installed as far back from the watercourse as possible through negotiation with the landowner, but should ideally be set a minimum of 5m back from the watercourse, or at the field-ward side of the bank top, whichever is the furthest.

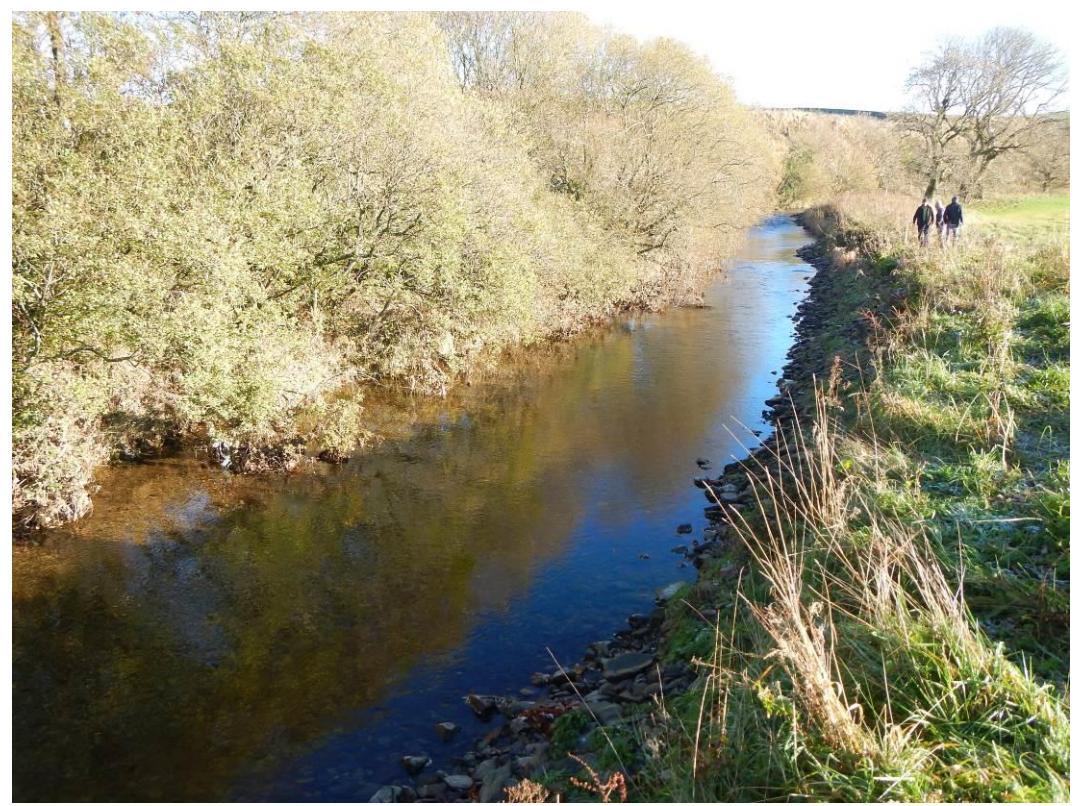
**Figure 3.** Looking upstream at the area of bank erosion (right of shot). Note the raised, relatively steep bank of coarse material. Re-grading this bank with a greater soil component and reinstating a more natural bank-top height and profile along this length would reduce its susceptibility to erosion.

If river relocation cannot be negotiated, another option would be to remove the excess coarse gravel and cobble material from the eroding bank area and repair it with a lower gradient, predominantly soil faced bank that can be planted with shrubs and reseeded/re-turfed. Gravel and cobble material resulting from the work could be reintroduced to the channel (if kept separate or mechanically separated from sine soil/silt) or used to fill the areas from which the soil for reinstating the new banks is sourced (this should be well back from the watercourse).

The height of reinstated bank should also be lowered, removing the floodbank and reinstating a more natural, even bank-top height. This will allow gradual overtopping of high flows along an extended length of bank, rather than in one localised area, where there is a greater risk of erosion (as occurs at present). Allowing the water to overspill naturally across a longer section riverbank will also create a more gradual loss of flow energy, rather than a dramatic loss within a short section that has potential to increase sediment deposition and block the channel. If such deposition did occur, it is likely to deflect even more water out of the channel and onto the adjacent field. For these reasons, all areas of the raised flood embankment should ideally be lowered and temporary utilisation of the floodplain by peak flows embraced as a predictable and easily manageable occurrence.

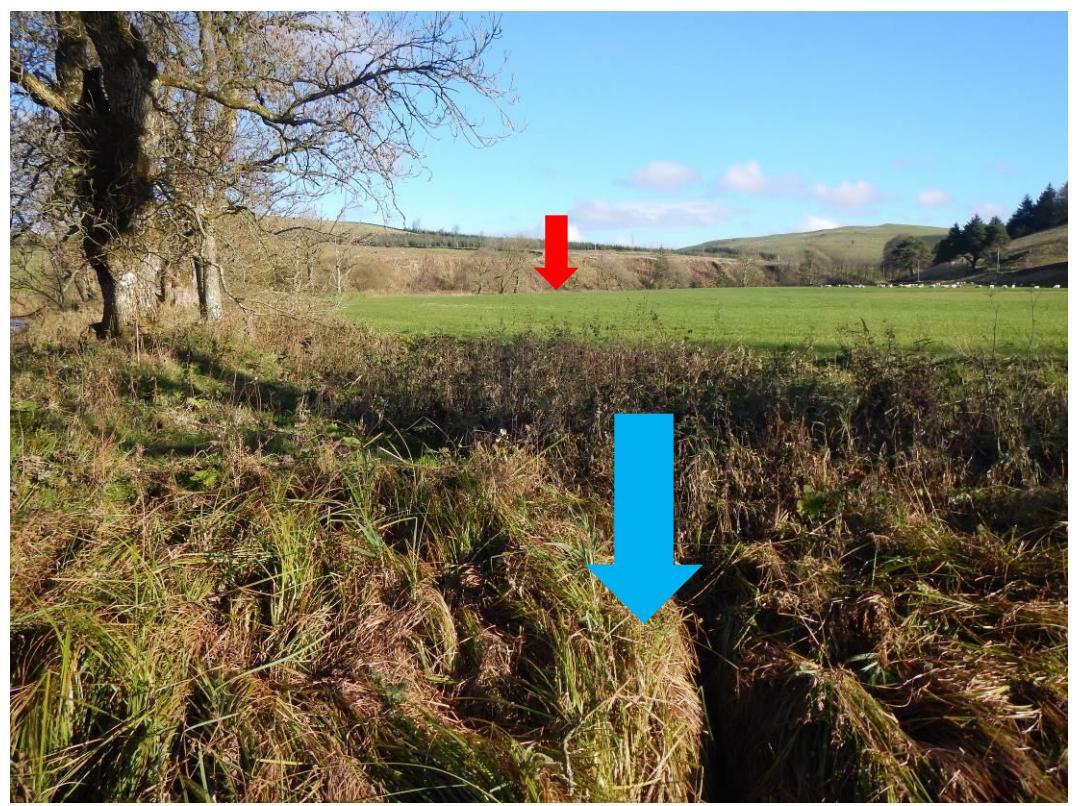
**Figure 4.** Looking upstream across the floodplain, from the low point of the field, at which out of bank flows return to the watercourse (blue arrow), up towards the point that river flows overspill (red arrow).

Allowing the watercourse to gradually spill out of a more natural channel onto a well vegetated pastoral field is unlikely to cause significant damage. Consider that out of bank flows already occur during flood conditions, with no detriment to the majority of the field. Providing there is a sufficient sward to prevent erosion along high flow pathways, and livestock have areas of high ground in which to seek refuge, the negative impact of out of bank flows is negligible. Therefore, the value of attempting to prevent a river from utilising its floodplain, rather than accepting and accommodating it is highly questionable, providing flows drains naturally when river levels subside (i.e. they are not constrained behind floodbanks). Fortunately, the site in question appears to drain effectively following a flood, with all of the high flow pathways appearing to connect with a low point in the bank at the d/s end of the field (Fig. 4).

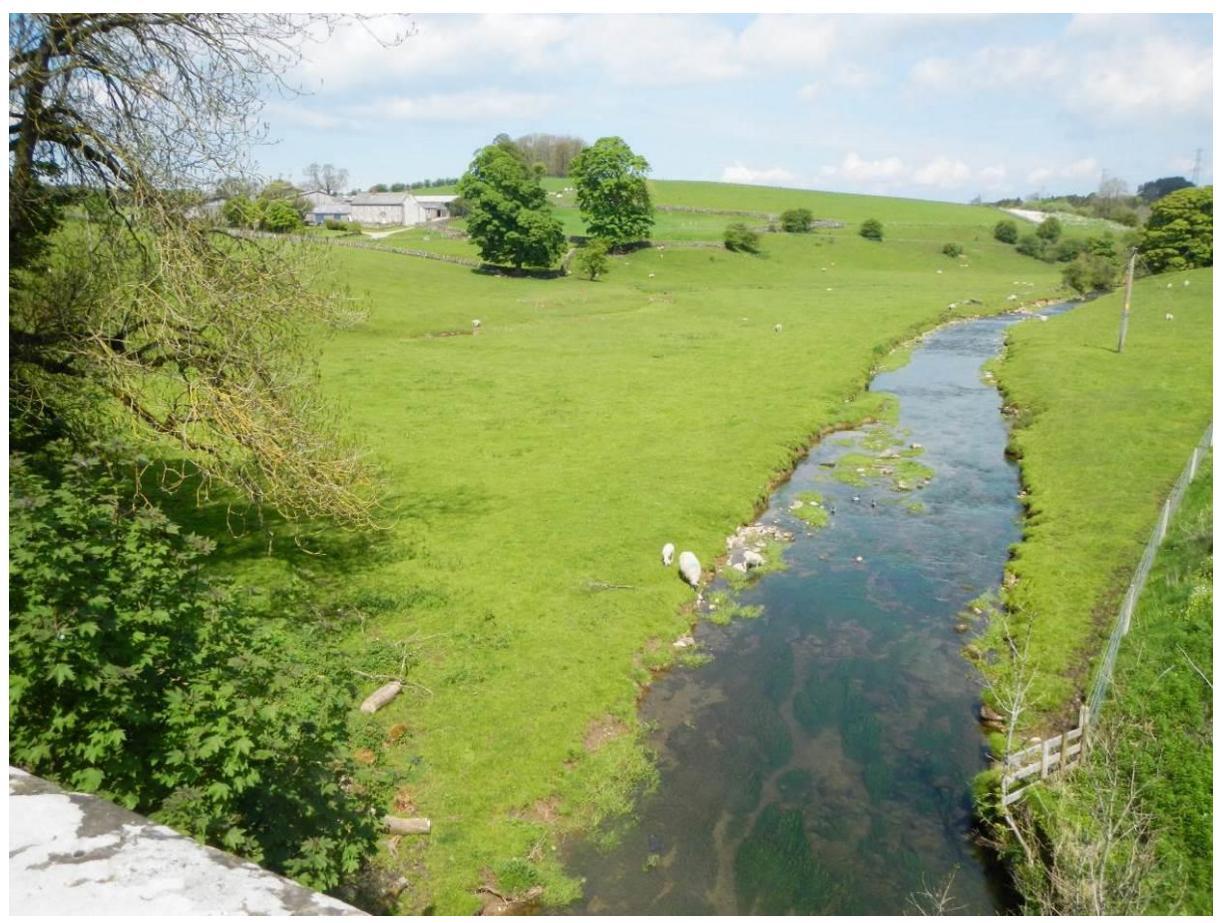
A1. Realigned channel in normal summer flows, before restoration.

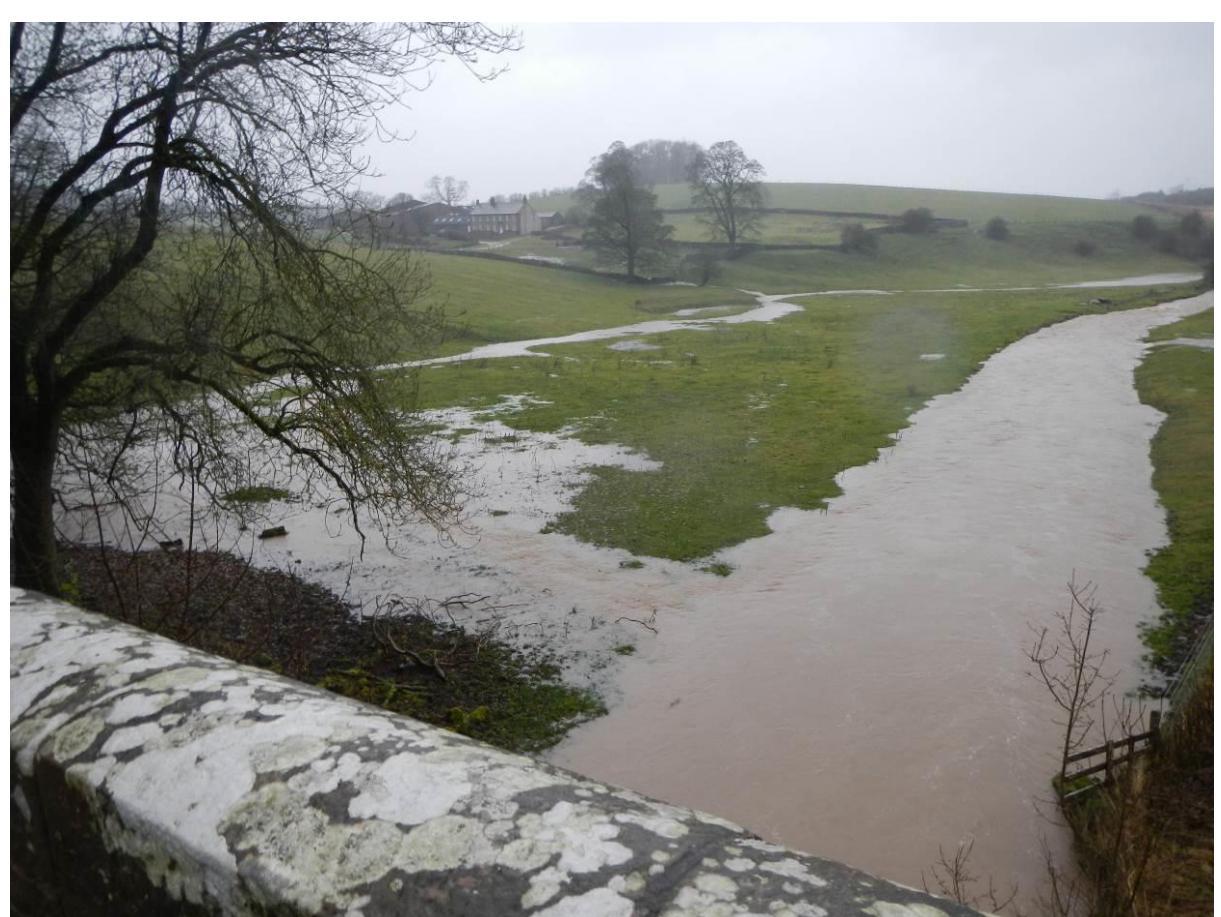
**A2.** Straightened, realigned channel over-spilling into the low point of the valley in high winter flows, before restoration.

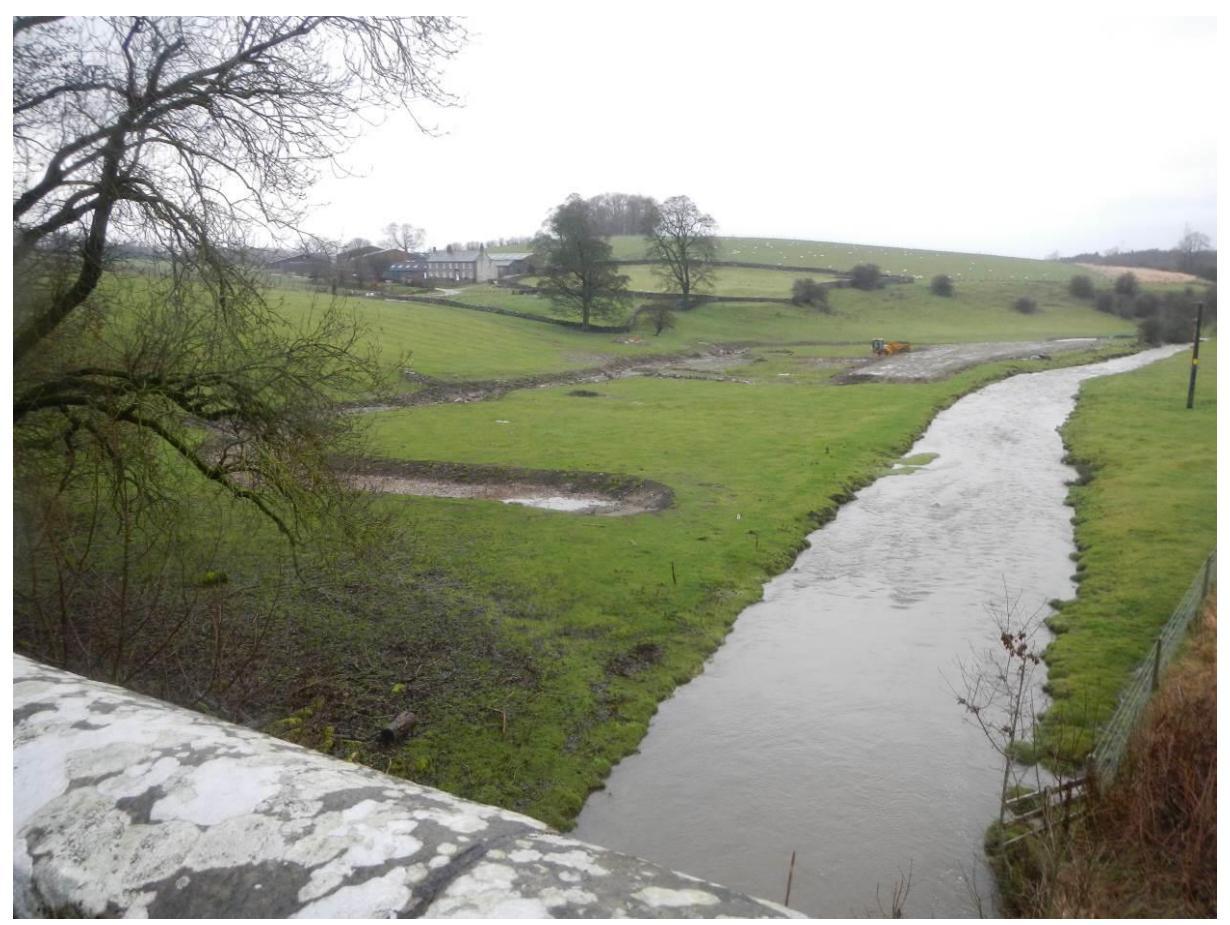
A3. Normal winter flows during restoration.

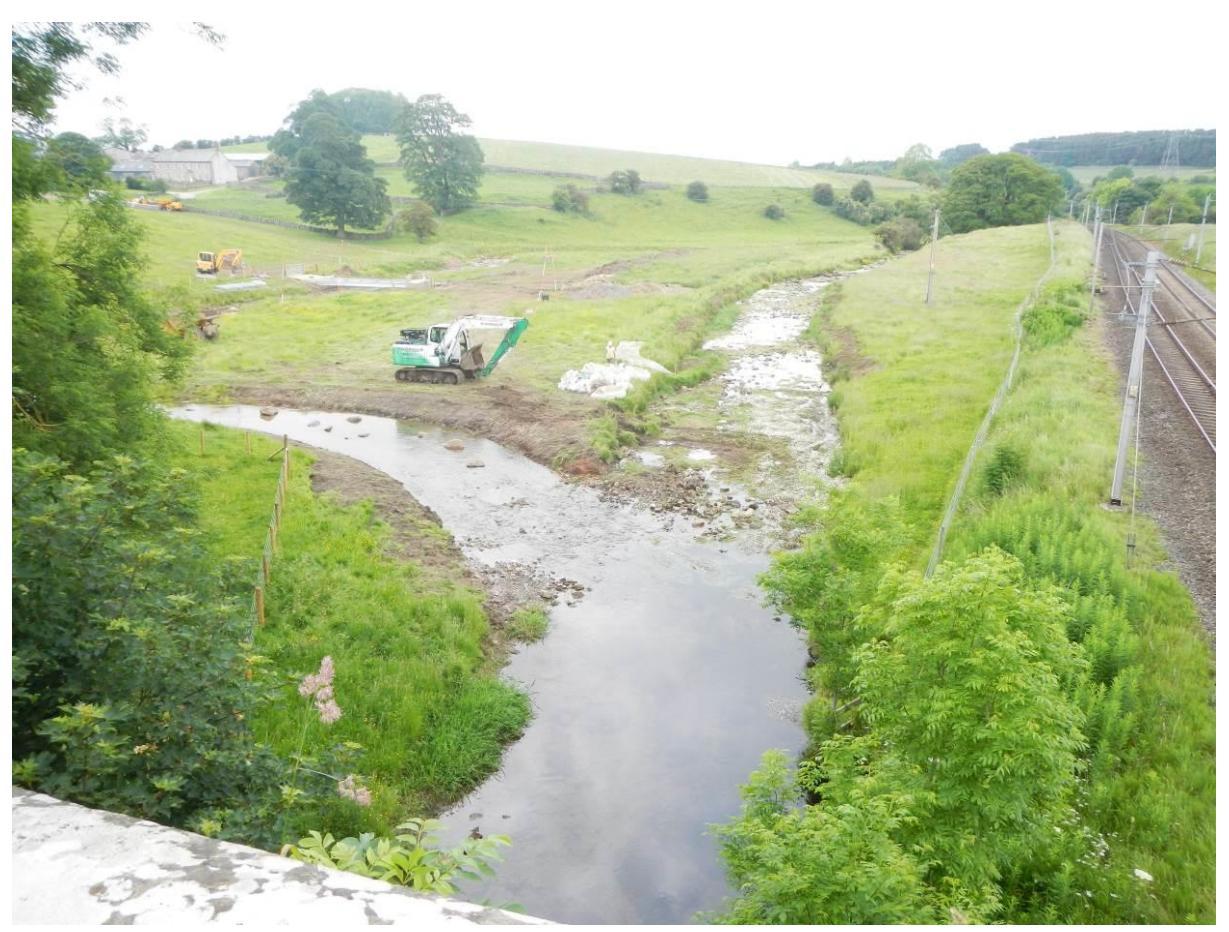
A4. Normal summer flows during restoration - reconnection phase.

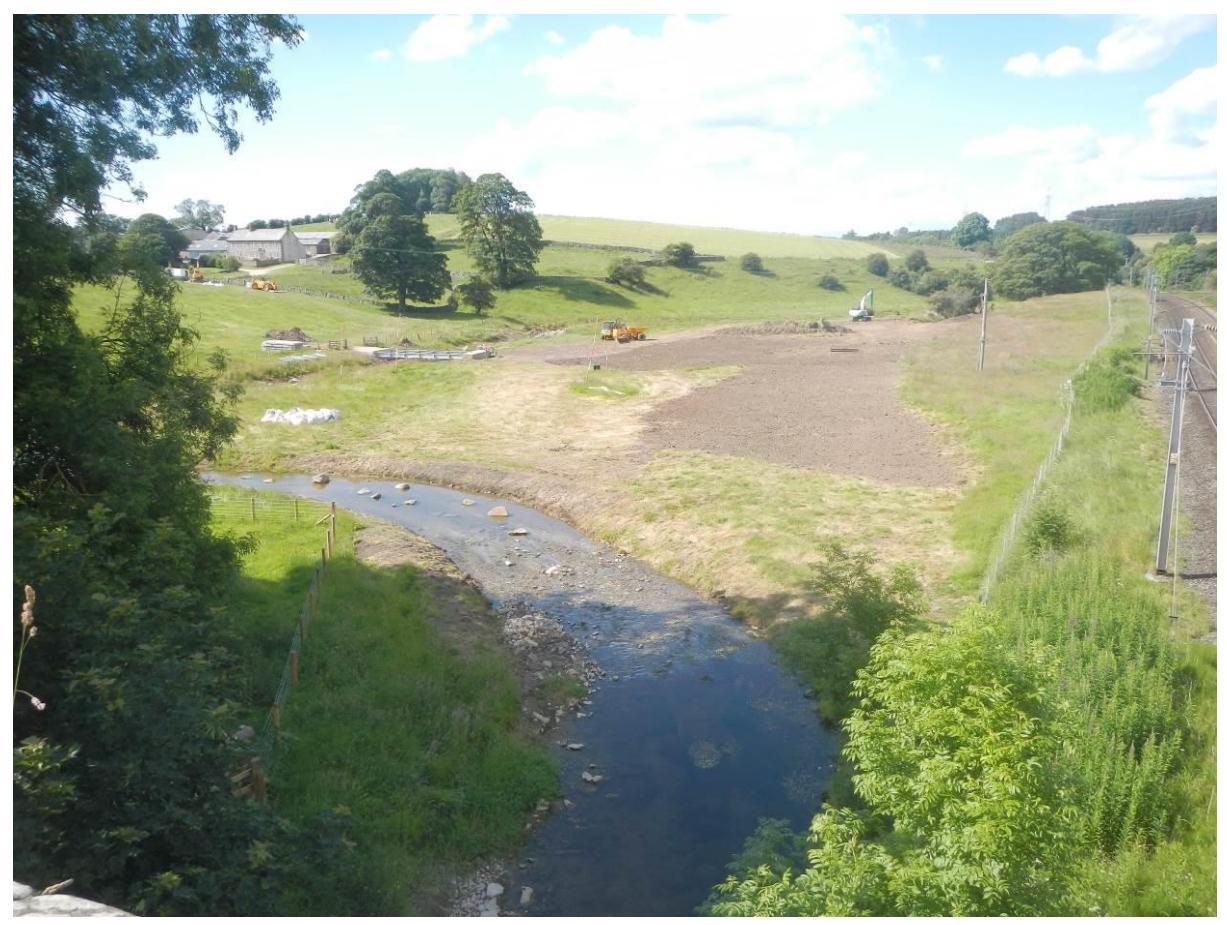
A5. Normal summer flows shortly after reconnection phase of the restoration.

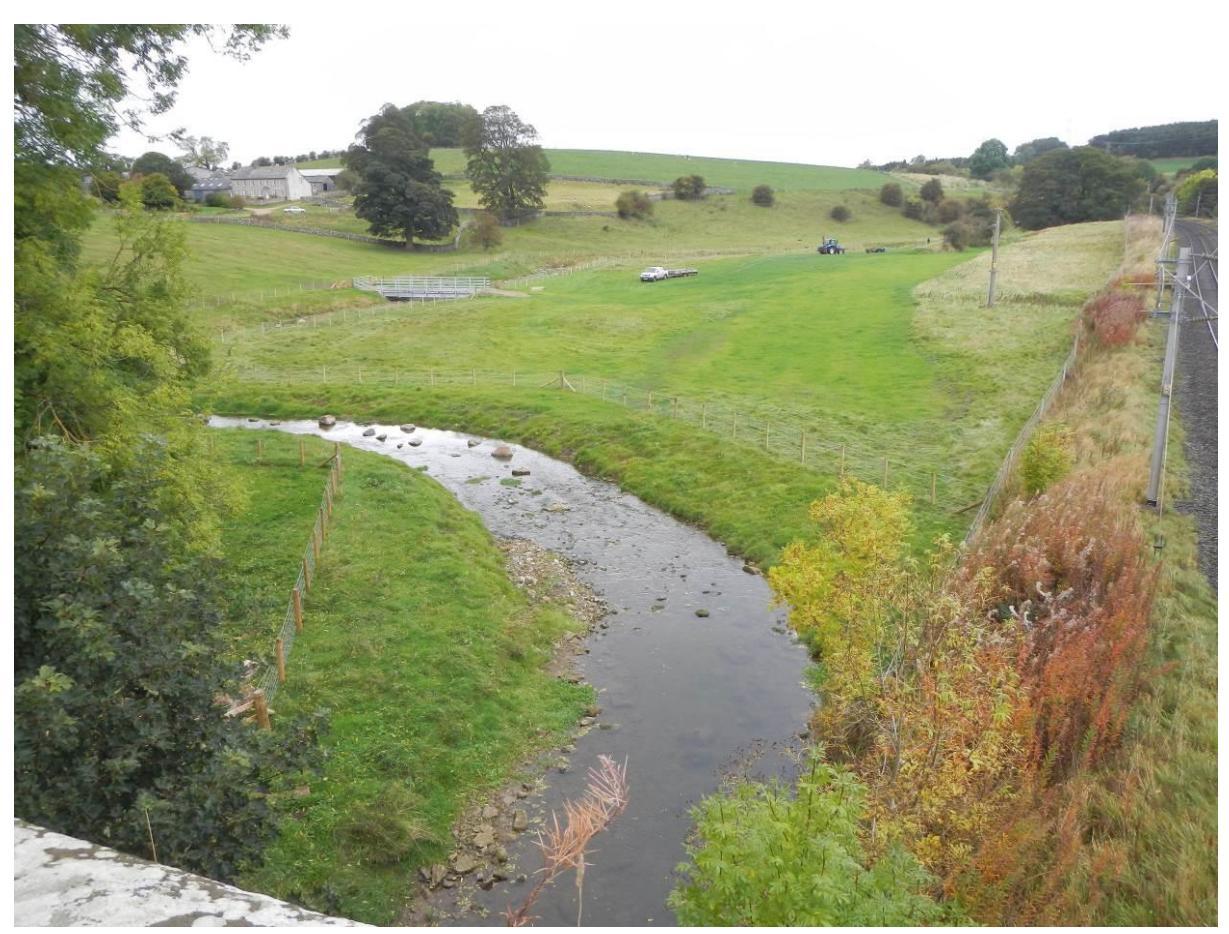
A6. Low summer flows after reseeding and vegetation regrowth.
